Port Tobacco River Conservancy

2016 Stream Monitoring Roundtable

Port Tobacco River Watershed

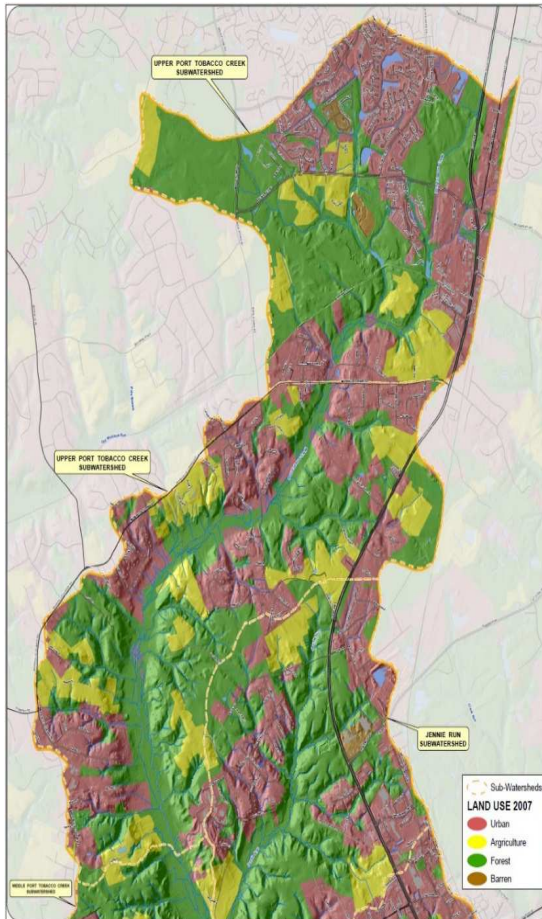
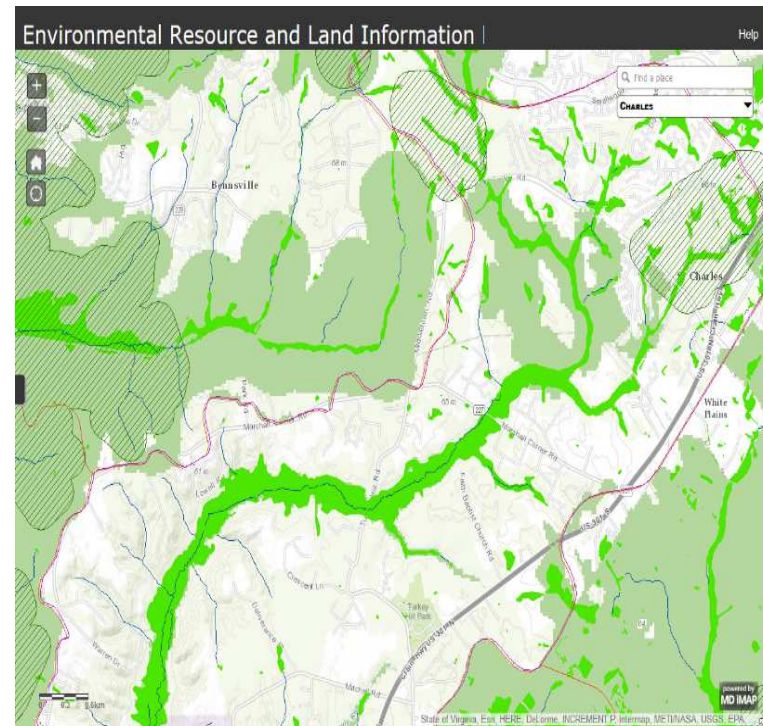
Focus on Headwaters

Upper Port Tobacco
subwatershed

Pages Swamp subwatershed
